IN RE: INTERRUPCIÓN DE SERVICIO
ELÉCTRICO DE 6 DE ABRIL DE 2022

CASE NO. NEPR-IN-2022-0002

**Costa Sur Outage Event
April 6, 2022**

Root Cause Evaluation

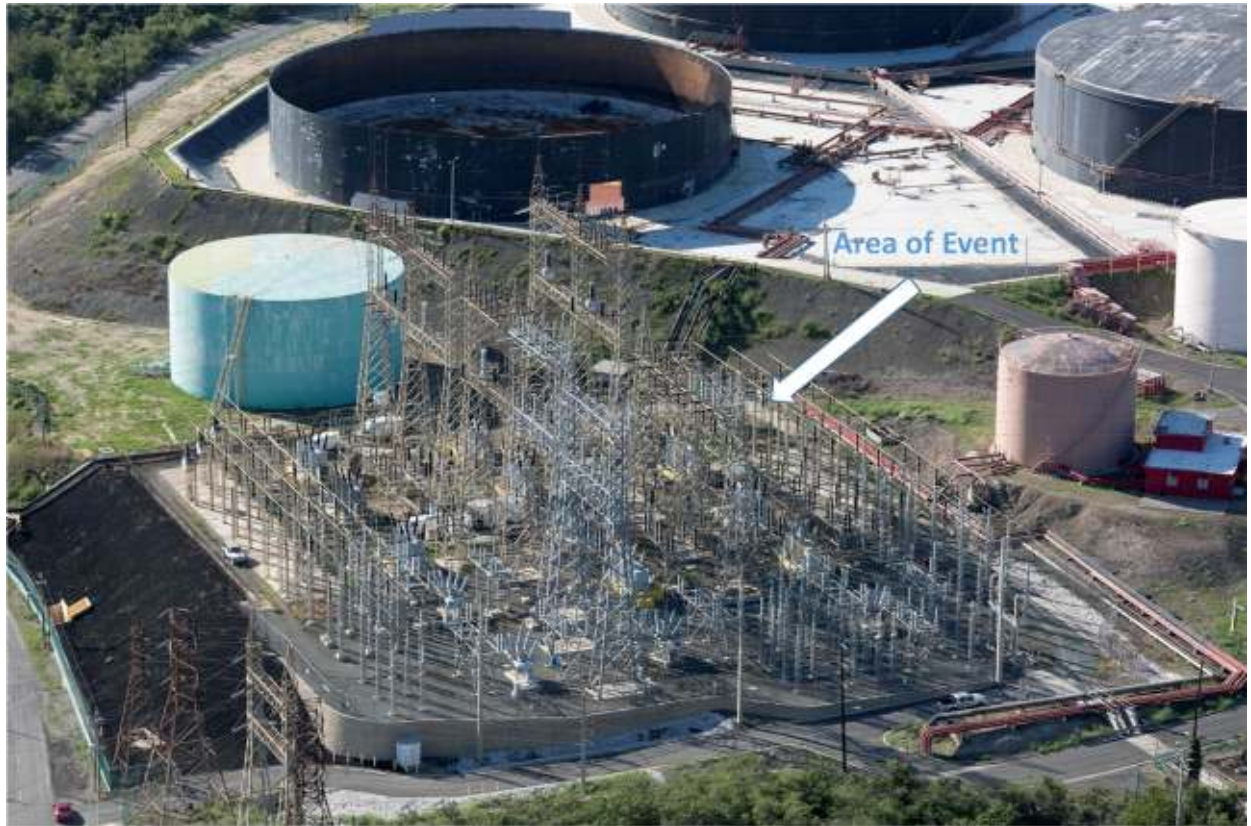
Figure 2: Costa Sur SP's 230 kV Switchyard (CB 0082 is in top right corner of photograph)

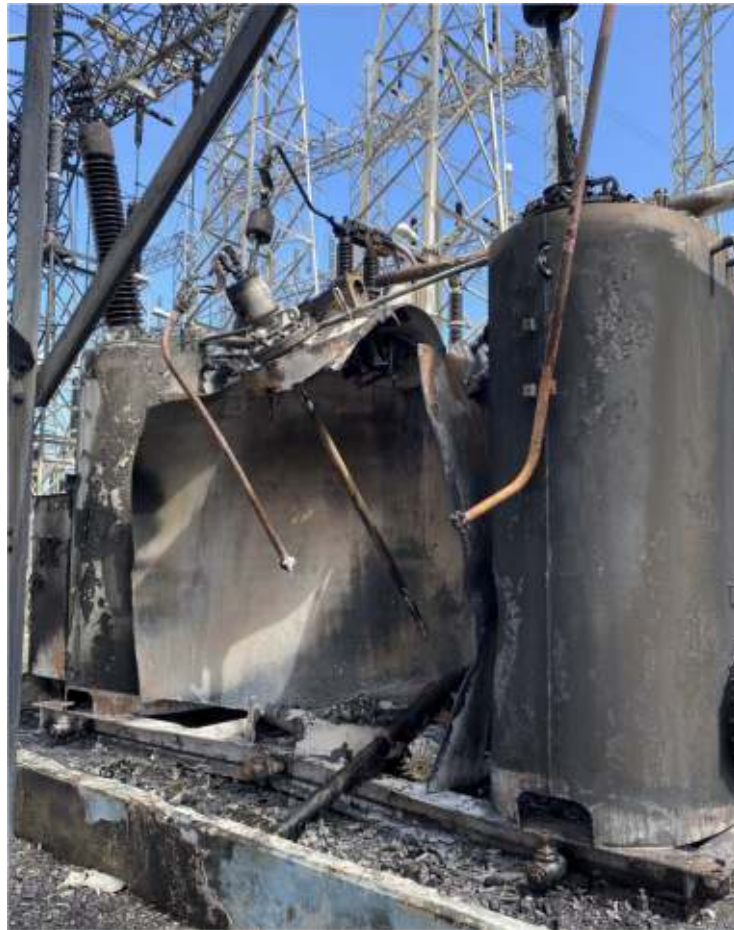
At 2042 hours on Wednesday, April 6th, 2022, a fault occurred in the 230 kV switchyard of the Costa Sur Steam Plant (SP). Phase B of Oil-Circuit Breaker (OCB) #0082 suffered a catastrophic failure (see Figure 5).¹ A detailed description of the event is provided in LUMA's Outage Event Progress Report¹. A summary of these analyses is described here.

Figure 5: Damaged OCB #0082

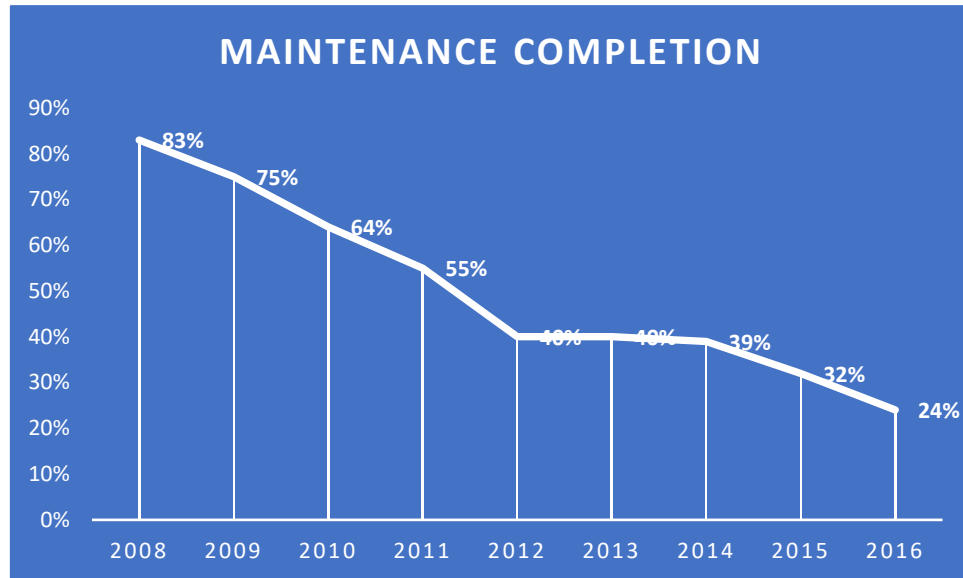
In 2016, PREPA indicated that the status of their electric system inspection and maintenance program was deteriorating.¹⁴ This information indicated that there were issues with both the maintenance program and the ability of PREPA to retain and recruit key personnel to manage the inspection and maintenance program effectively. PREPA indicated the following completion level of maintenance tasks, as shown in Figure 7. As indicated by the results in Figure 7, the effective maintenance completion declined continuously from 2008 to 2016 to the extent that only 24% of maintenance was being completed within its required time period. The impact of this condition is that asset condition deteriorates without the appropriate attention and leaves the system in a vulnerable state relative to equipment condition and reliability.

Figure 7: PREPA Maintenance Completion¹⁴

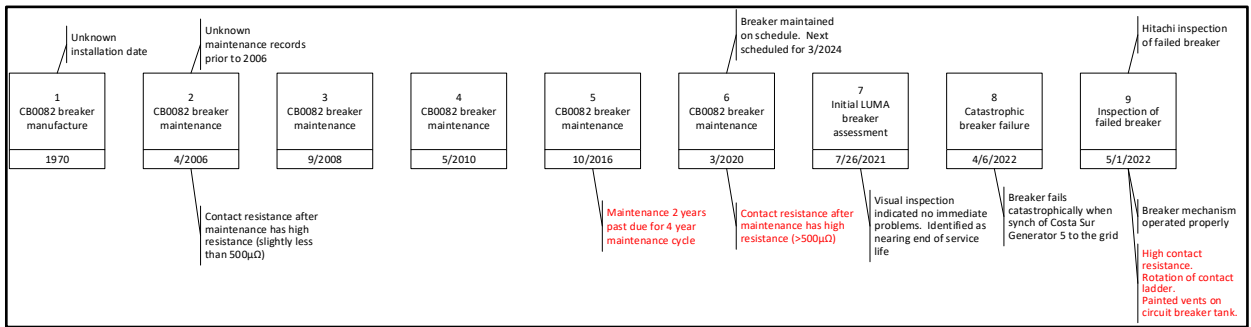
Figure 8: OCB #0082 Maintenance History Timeline

The circuit breaker maintenance was documented for 2006, 2010, 2016, and 2020. The next scheduled maintenance would be 2024. All of the breaker maintenance was performed by PREPA. Key findings from the review of the maintenance data are:

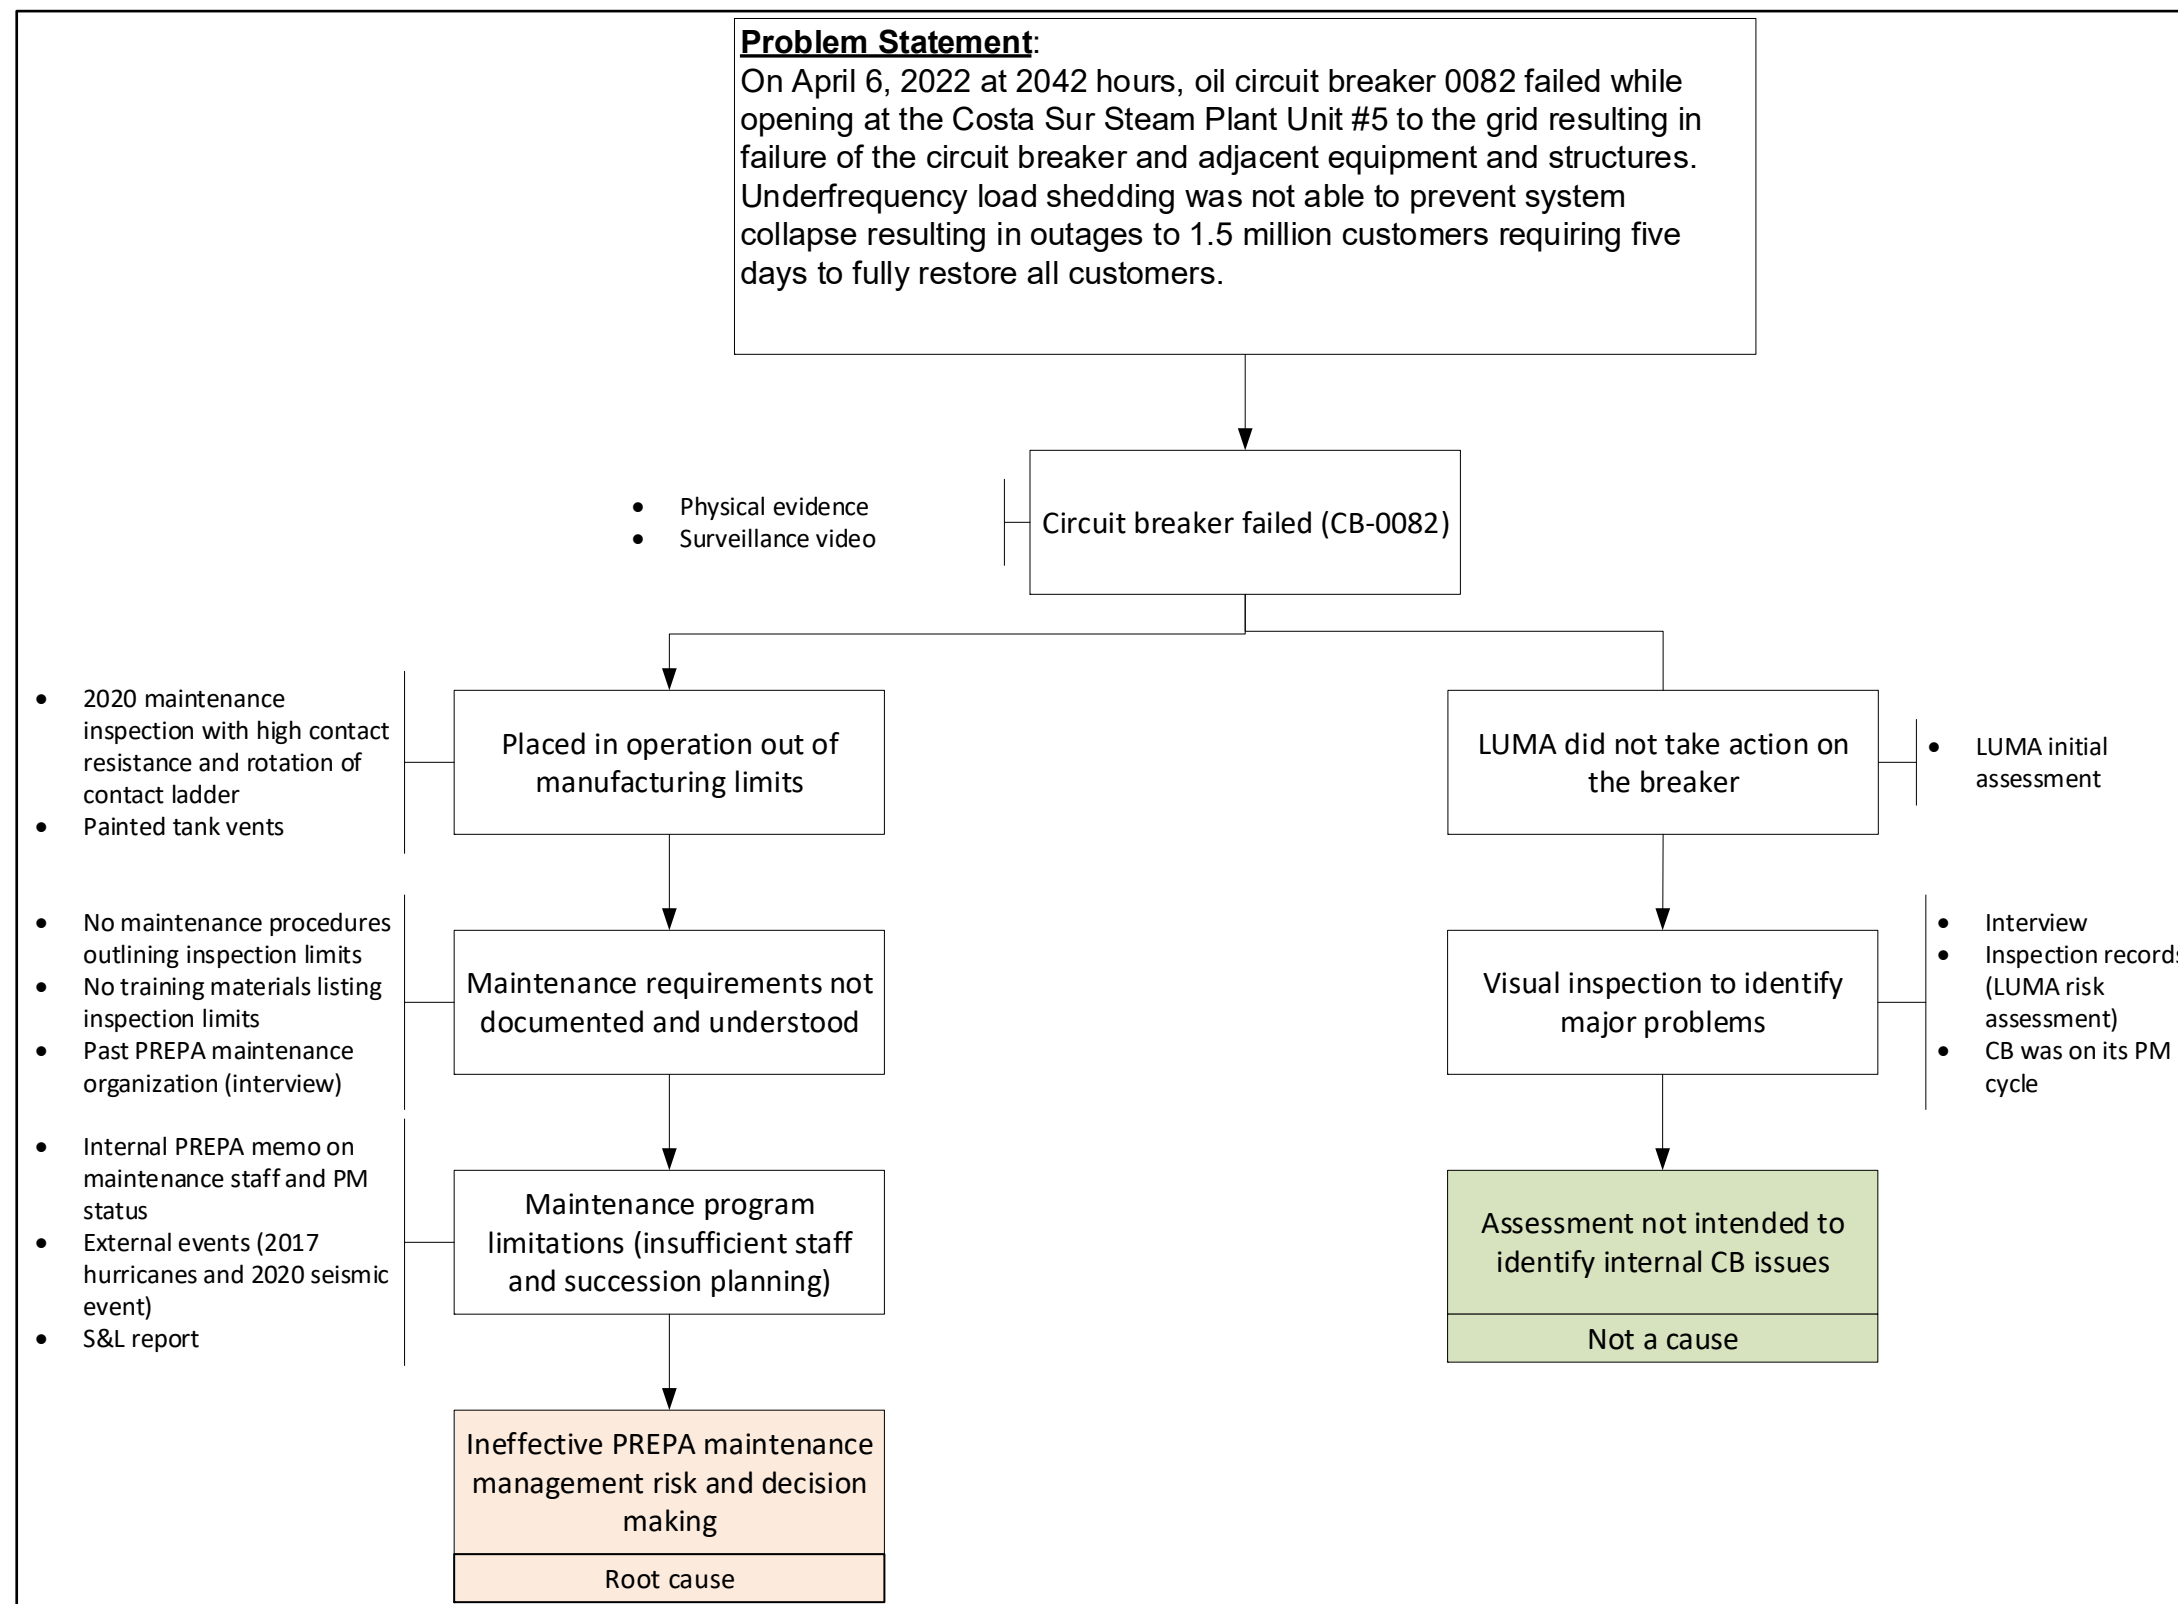
Root Cause 1: Ineffective PREPA maintenance management and decision-making led to the Oil-Circuit Breaker (OCB) #0082 breaker being placed into service by PREPA after maintenance in 2020 with contact resistance significantly over the manufacturer's recommended limits. Exponent states that PREPA should not have placed the OCB #0082 back in service with this high level of contact resistance. This resulted in arcing across the contacts in the circuit breaker, heating the oil in the equipment which vaporized the oil, creating high pressure hydrogen that could not be released and resulted in the explosion.

Figure 9: Causal Analysis of Failed Circuit Breaker

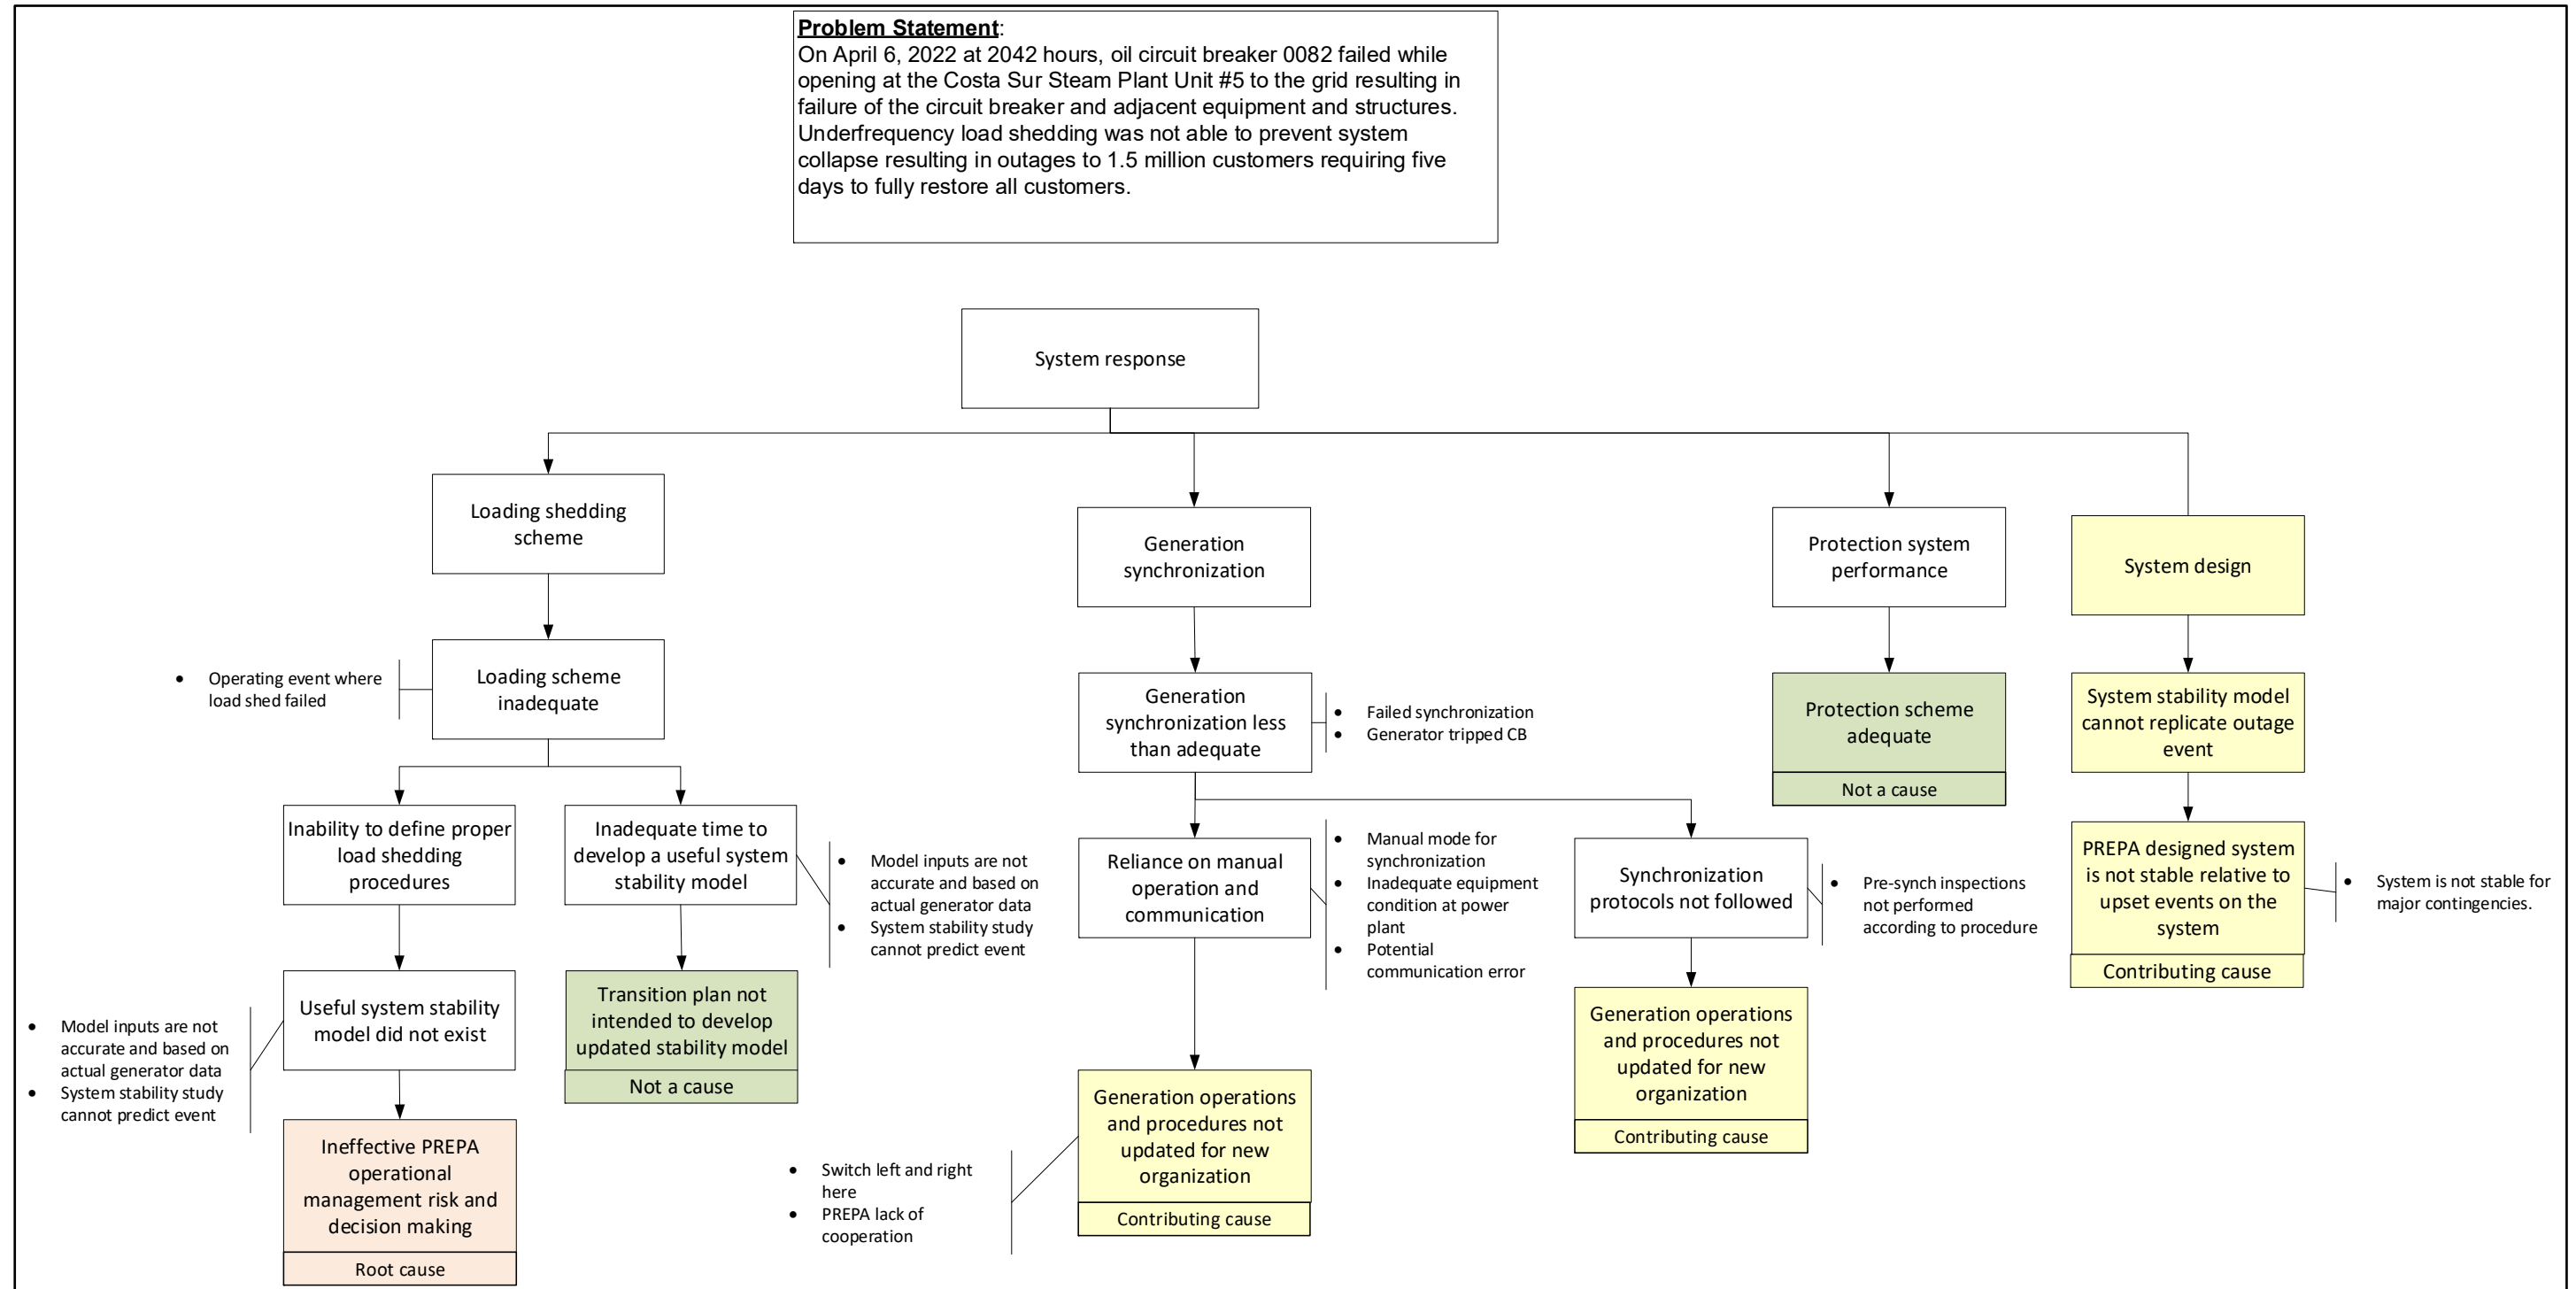
Root Cause 2: Ineffective PREPA operational management and risk decision-making resulting from not having a system stability model to assist in development of load shedding schemes. The protection devices for the most part functioned as intended after the explosion of OCB#0082. When the Costa Sur and Ecoeléctrica plants disconnected, the under-frequency load shed was insufficient to stabilize the system and a blackout occurred. An accurate system stability model that includes generator performance characteristics, helps determine how much load shed is needed to maintain the balance between generation and load and prevent island wide blackouts of the electric system. Despite multiple requests from LUMA, PREPA has not provided access to the generator performance data needed to create the system model.

Figure 10: Causal Analysis : System Response
