IN RE: INTERRUPCIÓN DE SERVICIO
ELÉCTRICO DE 6 DE ABRIL DE 2022

CASE NO. NEPR-IN-2022-0002

**Costa Sur Outage Event
April 6, 2022**

Root Cause Evaluation

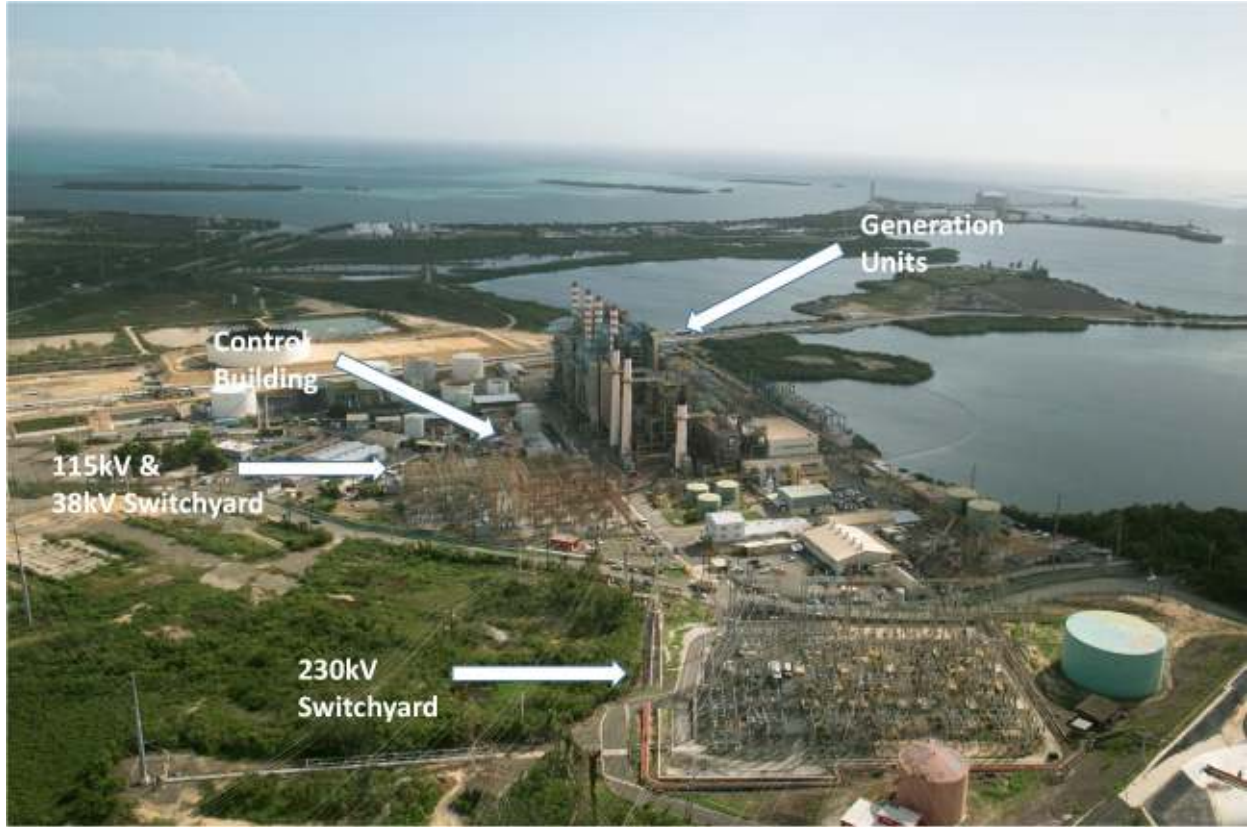
The Costa Sur Steam Plant (SP) is a network of facilities involving the thermal generation plant and the electrical facilities, including the 230 kV Switchyard and 115/38 kV Switchyards (see Figure 1). Costa Sur's 230 kV switchyard has a breaker and a half configuration with five bays that include four (4) gas circuit breakers and 11 oil circuit breakers from circa 1969-1976. Figure 2 provides an aerial view of the 230 kV Costa Sur Switchyard.

Figure 1: Aerial View of Costa Sur Steam Plant Prior to April 6th Event (switchyard is in foreground of photograph)
